**Flood Control Project Maintenance**  
**2018 Structure Summary Report**  
**Overall Unit and Item Ratings**

## Lake County Watershed Protection District

### Clover Creek Diversion Structure

**Flood Control Project Maintenance**  
**Unit Cover Sheet**  
**2018 Structure Inspection Results**

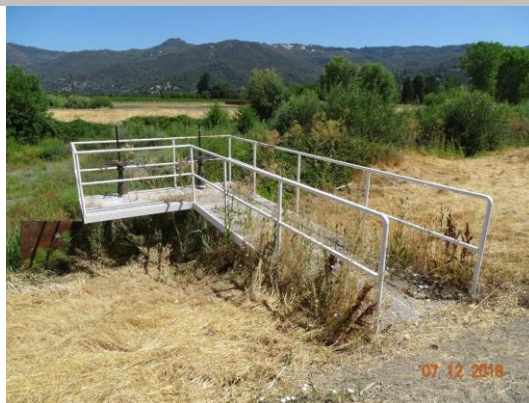
Photo 1 of 1 : ST\_2018\_NA0009\_36\_1\_20180716\_00011.jpg

LM Start	0.00	Rating **	N	Issue No.	1
LM End	0.00	Issue Type +	Ma	Location *	
Category	Structures & Concrete Lined Channels	GPS Latitude/Longitude			
		Start		End	
Item	Photo Documentation	39.177050 °		39.177050 °	
		-122.898750 °		-122.898750 °	
DWR ID	DWR_NA0009_36_t_2012_1				
Action/Comments					
Inspector Comments: Clover Creek Diversion Structure has three culverts with two slide gates, and a gate to divert the water during high water season.

View of the structure. Summer 2018.

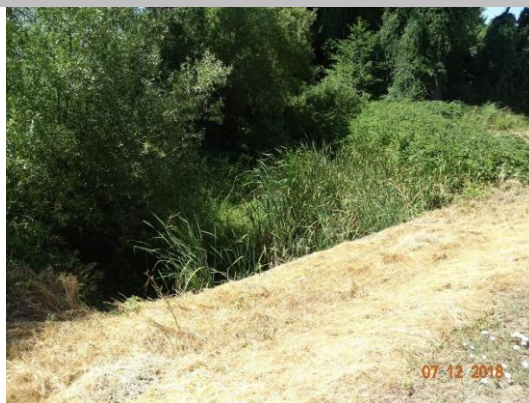
Photo 1 of 4 : ST\_2018\_NA0009\_36\_2\_20180716\_00012.jpg

LM Start	0.00	Rating **	A	Issue No.	2
LM End	0.00	Issue Type +	Ma	Location *	
Category	Structures & Concrete Lined Channels	GPS Latitude/Longitude			
		Start		End	
Item	Vegetation & Obstructions	39.177050 °		39.177050 °	
		-122.898750 °		-122.898750 °	
DWR ID	DWR_NA0009_36_t_2012_2				
Action/Comments					
Inspector Comments: The channel had minimal vegetation and scattered obstructions, but the flow is not impeded.

View of the vegetation at the outlet of the structure. Summer 2018.

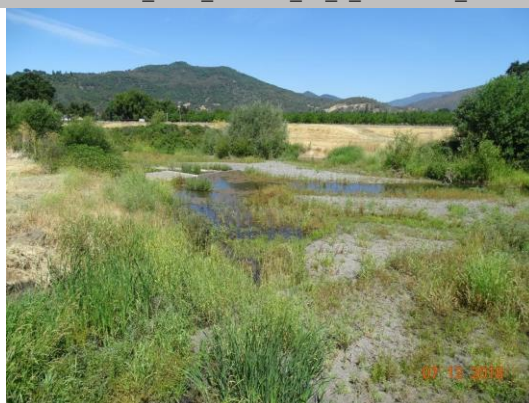
Photo 2 of 4 : ST\_2018\_NA0009\_36\_2\_20180716\_00013.jpg

View of the vegetation downstream of the structure. Summer 2018.

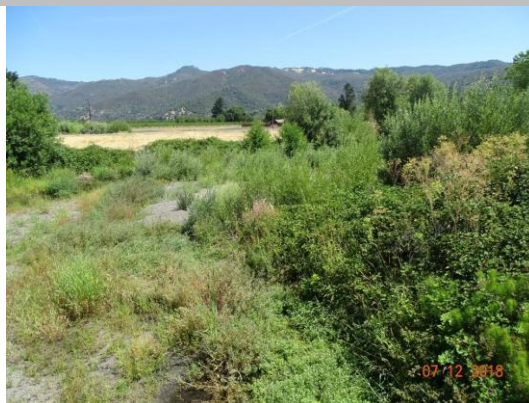
Photo 3 of 4 : ST\_2018\_NA0009\_36\_2\_20180716\_00014.jpg

LM Start	0.00	Rating **	A	Issue No.	2 (cont)	
LM End	0.00	Issue Type +	Ma	Location *		
Category	Structures & Concrete Lined Channels			GPS Latitude/Longitude		
				Start		End
Item	Vegetation & Obstructions			39.177050 °		39.177050 °
				-122.898750 °		-122.898750 °
DWR ID	DWR_NA0009_36_t_2012_2					
Action/Comments						
Inspector Comments: The channel had minimal vegetation and scattered obstructions, but the flow is not impeded.

View of the vegetation upstream of the structure. Summer 2018.

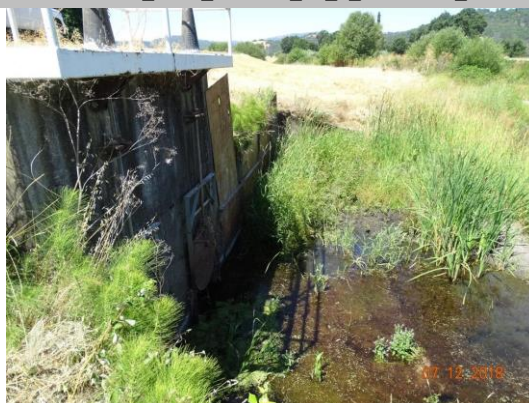
Photo 4 of 4 : ST\_2018\_NA0009\_36\_2\_20180716\_00018.jpg

View of the minor vegetation at the headwall. Summer 2018.

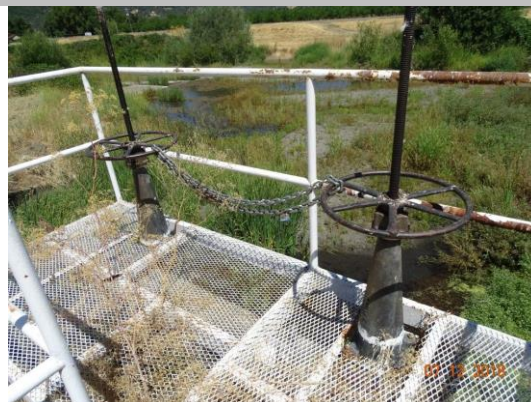
Photo 1 of 1 : ST\_2018\_NA0009\_36\_14\_20180716\_00017.jpg

LM Start	0.00	Rating **	A	Issue No.	14
LM End	0.00	Issue Type +	Ma	Location *	
Category	Structures & Concrete Lined Channels	GPS Latitude/Longitude			
		Start	End		
Item	Manual Gate Operators	39.177050 °		39.177050 °	
		-122.898750 °		-122.898750 °	
DWR ID	DWR_NA0009_36_t_2012_14				
Action/Comments					
Inspector Comments: The manual gate operators appeared to be operational.

View of the manual gate operators. Summer 2018.
